KENTUCKY HISTORIC RESOURCES
INDIVIDUAL SURVEY FORM
(KHC 91-1)

COUNTY Lewis
RESOURCE# Lw-20
RELATED GROUP #
INTENSIVE DOC.
EVALUATION 5
DESTROYED

1. NAME OF RESOURCE (how determined): 1 /
Purcell - McGlone House
2. ADDRESS/LOCATION: South side of Engle Rd. approx.
1 mile west of Crooked Creek Rd. intersection

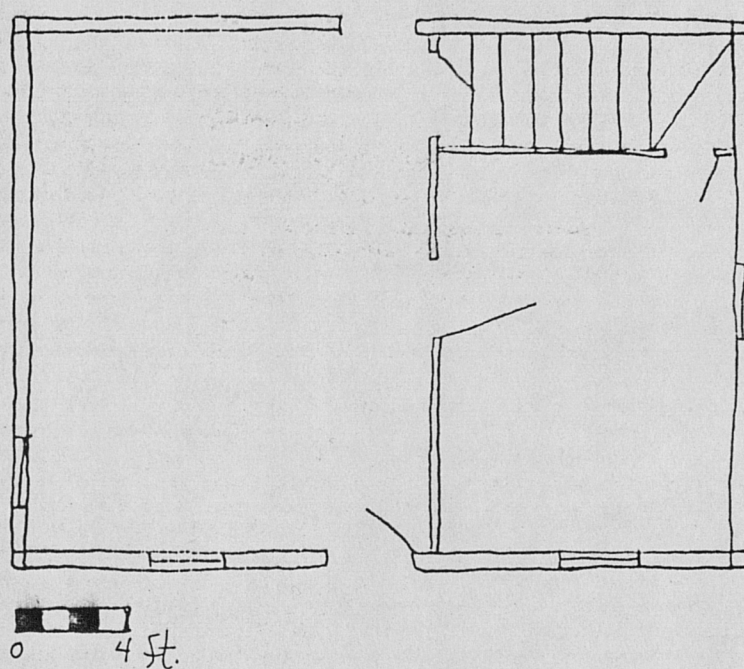
Figure 10. Plan of the Purcell-McGlone House (LW-20)

14. CONSTRUCTION METHOD/MATERIAL:
2 / 3 / Log / Half Dovetail original
 / / subsequent
15. DIMENSIONS:
Height 1.5 Width 3 Depth 1
16. PLAN:
E / Hall - Parlor first
 / second
 / third

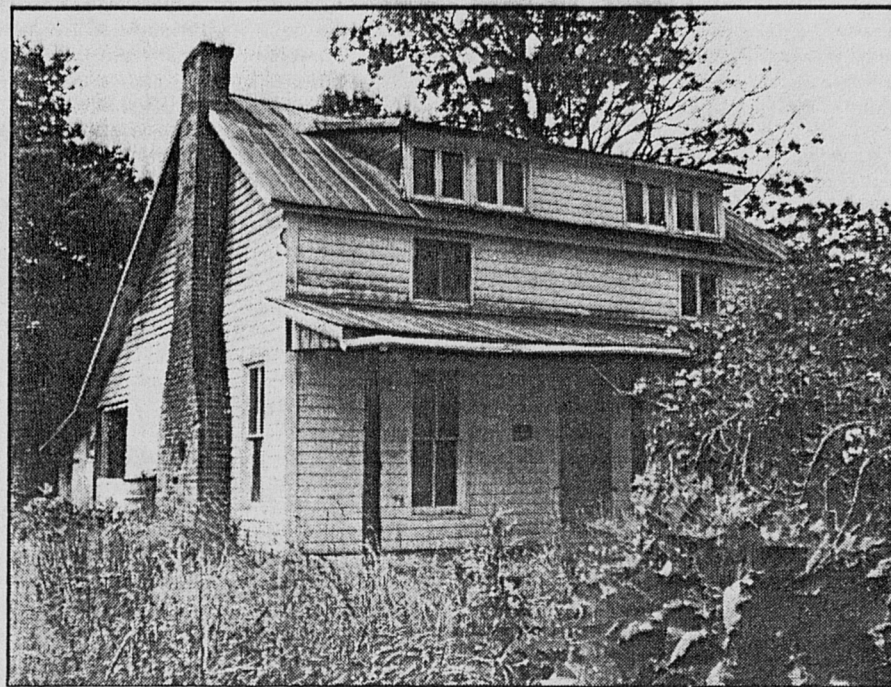
Plate 18. Purcell-McGlone House (LW-20)

12. CONSTRUCTION DATE: 6 / c. 1850 estimated
 / / / / / documented
13. DATE OF MAJOR MODIFICATIONS (specify):
3 / Chimney, porch, windows, dormer, rear additions
 / interior alterations - mantel, woodwork

22. CONDITION: G / good
23. MODIFICATION: 3 / Major
24. NEGATIVE FILE #: 92/08/ 2-9
Write resource # on back of all prints.
-
